# Manhole Inspection Summary

Manhole # S33I\_\_028MH

Insp Date: **11/20/08 10:17 AM**

**Location** Address: **w.pratt st**

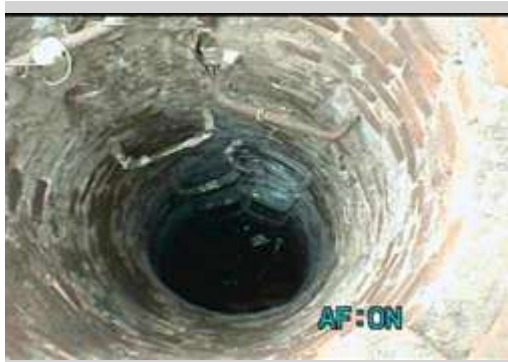
### Defect 1

missing/corroded steps

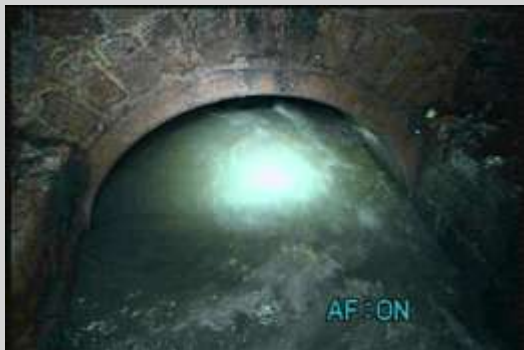
12 O'Clock Outflow

Deposits: ☒ None ☐ Mud ☐ Sludge ☐ Debris ☐ Grease

Infiltration: **None** Pipe Seal Cond: **Unknown**

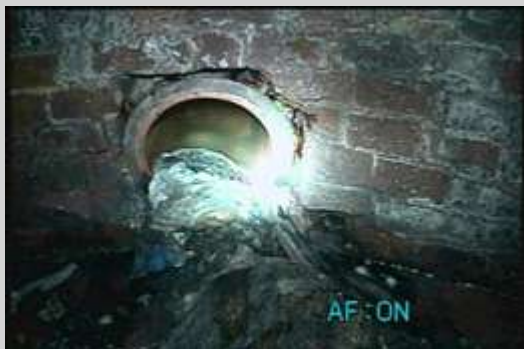
3 O'Clock Inflow

Deposits: ☐ None ☐ Mud ☐ Sludge ☒ **Debris** ☐ Grease

Silt Depth: 0 (in.) Deposits Extent: **Light**

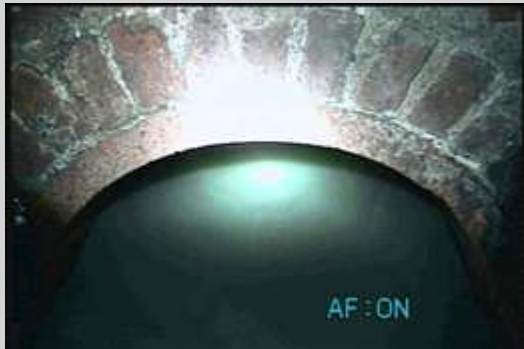
6 O'Clock Inflow

Deposits: ☒ None ☐ Mud ☐ Sludge ☐ Debris ☐ Grease

Infiltration: **None** Pipe Seal Cond: **Unknown**

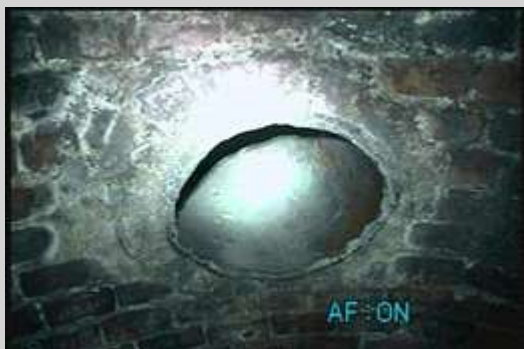
9 O'Clock Inflow

Deposits: ☒ None ☐ Mud ☐ Sludge ☐ Debris ☐ Grease

Infiltration: **None** Pipe Seal Cond: **Unknown**

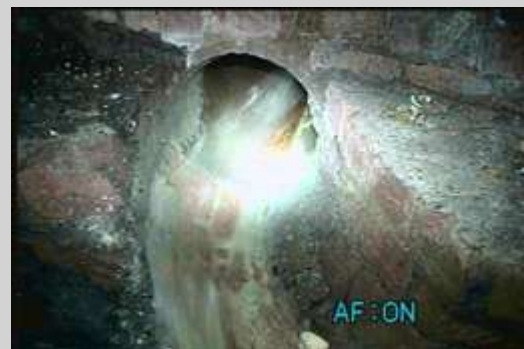
Drop In @ 9 O'Clock

Drop: **Outside Direct**

Drop Condition: **Open**
